NATIONAL TRANSPORTATION SAFETY BOARD
Washington, D. C. 20591

ALITALIA AIRLINES
McDONNELL-DOUGLAS DC.8.62. I-DIWZ
(ITALIAN REGISTRY)
JOHN F. KENNEDY INTERNATIONAL AIRPORT
JAMAICA, NEW YORK
SEPTEMBER 15, 1970

NATIONAL TRANSPORTATION SAFETY BOARD
 Washington, D. C. 20591
 AIRCRAFT ACCIDENT REPORT

Adopted: April 28, 1971

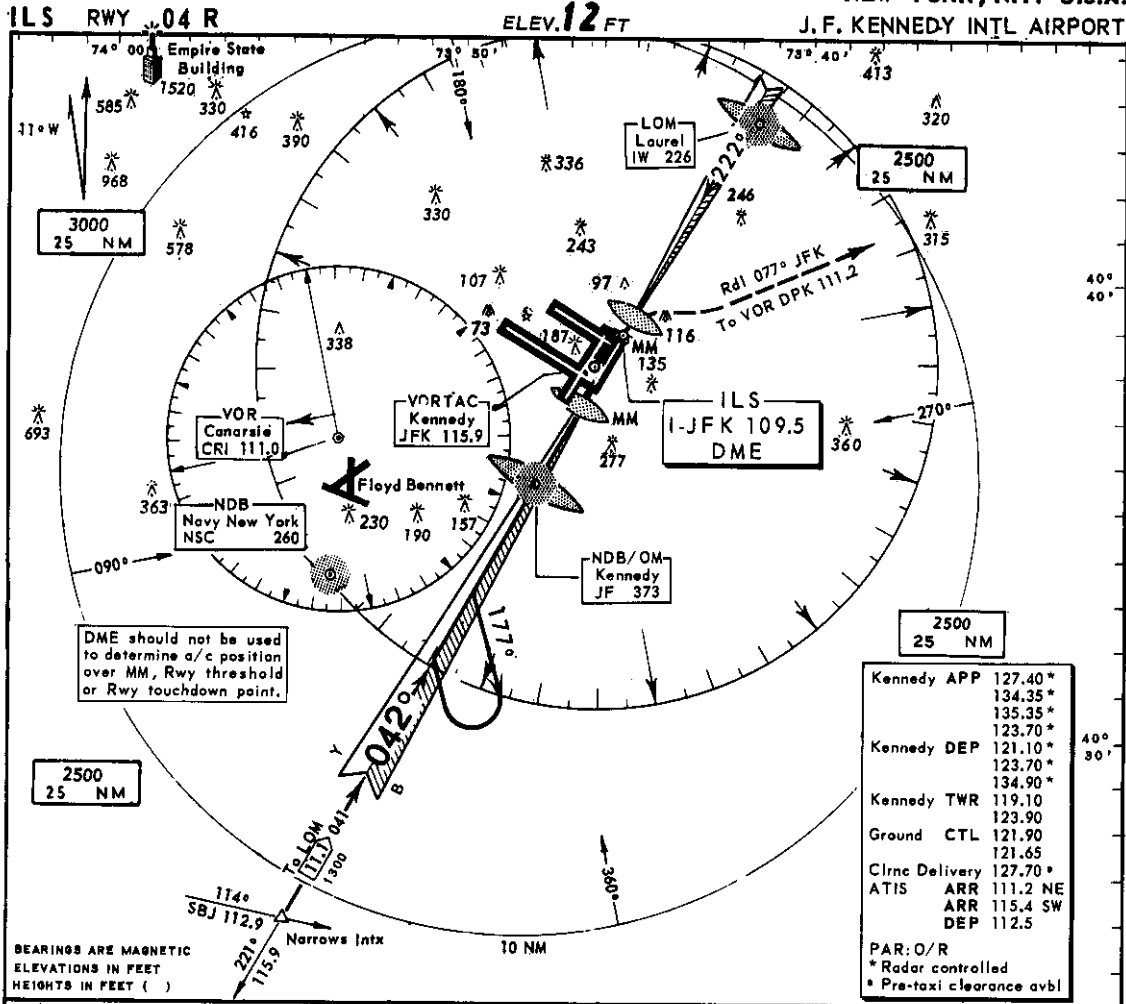
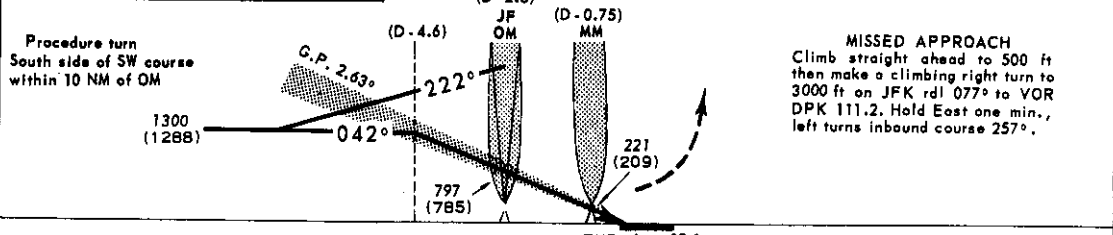
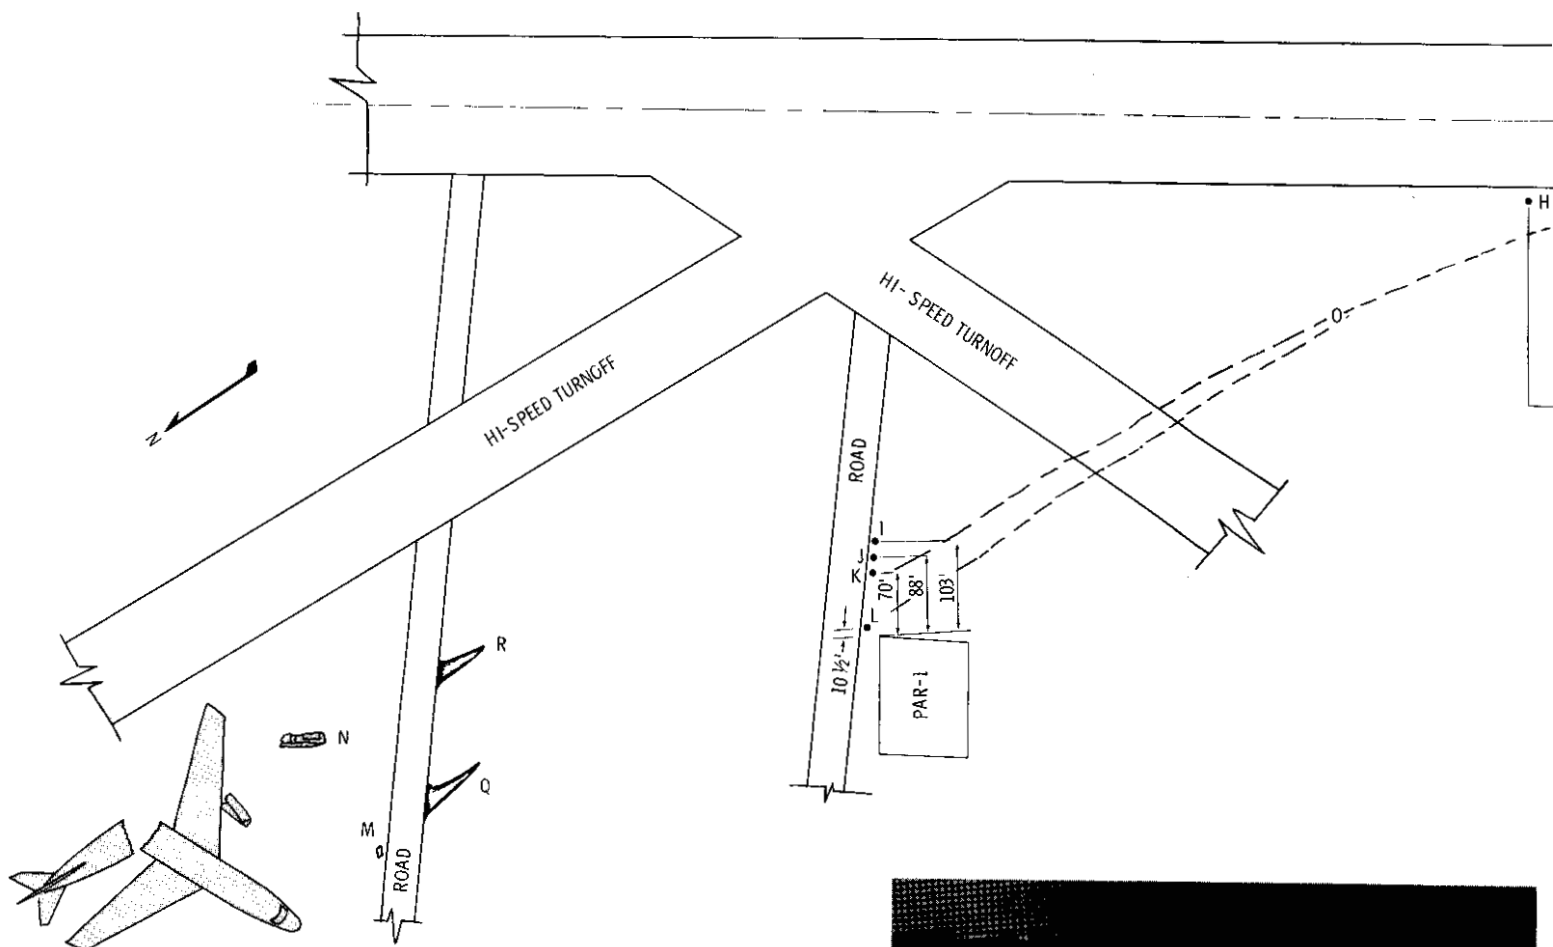
APPROACH CHART
ILS RWY 04 R

One of the significant factors in this regard was the vectoring procedures utilized by ATC with Flight 618 approaching JFK under IFR conditions and in the absence of an operating ILS glide slope. The absence of this glide slope information meant that the crew had to depend primarily on their DME indicator to provide them with their start-of-descent point. On the ILS approach to Runway 4R at JFK, the start-of-descent point is a DME fix, 4.6 NM from the runway threshold. This fix precedes the outer marker by 1.8 NM. Consistent with usual air carrier practice, Alitalia begins their instrument approach checklist sequence after capture of the localizer course and the glide slope indications.

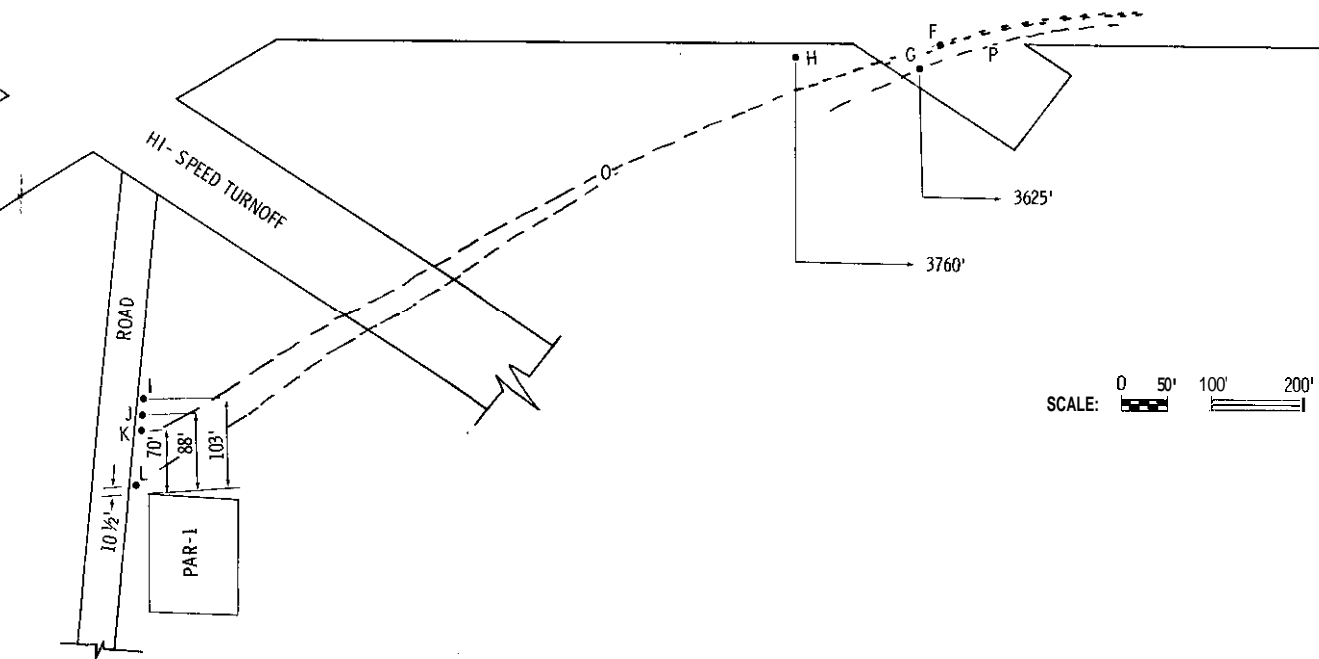
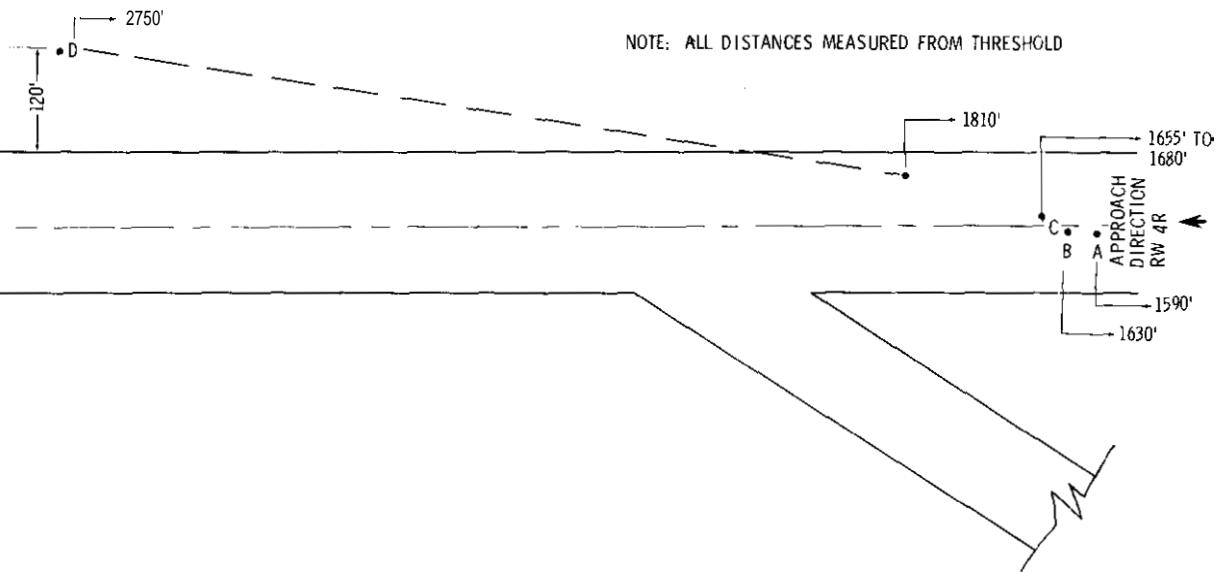
WRECKAGE DISTRIBUTION CHART
ALITALIA DOUGLAS DC-8, I-DIWZ
J.F. KENNEDY INTERNATIONAL AIRPORT, N.Y.
September 15, 1970

The first indication of a touchdown on the runway surface was a sharply defined score beginning 1,590 feet beyond the threshold of Runway 4R. This score was approximately one-half inch wide and varied in depth to three-

quarters of an inch. The score was located 9 inches to the left of the runway centerline. (See Appendix D for wreckage distribution chart and location of scoring marks on the runway.)
